# Ernestown Wind Park

## *Water Assessment Report* DRAFT

Prepared by: *M.K. Ince and Associates Ltd.*

September 14, 2012

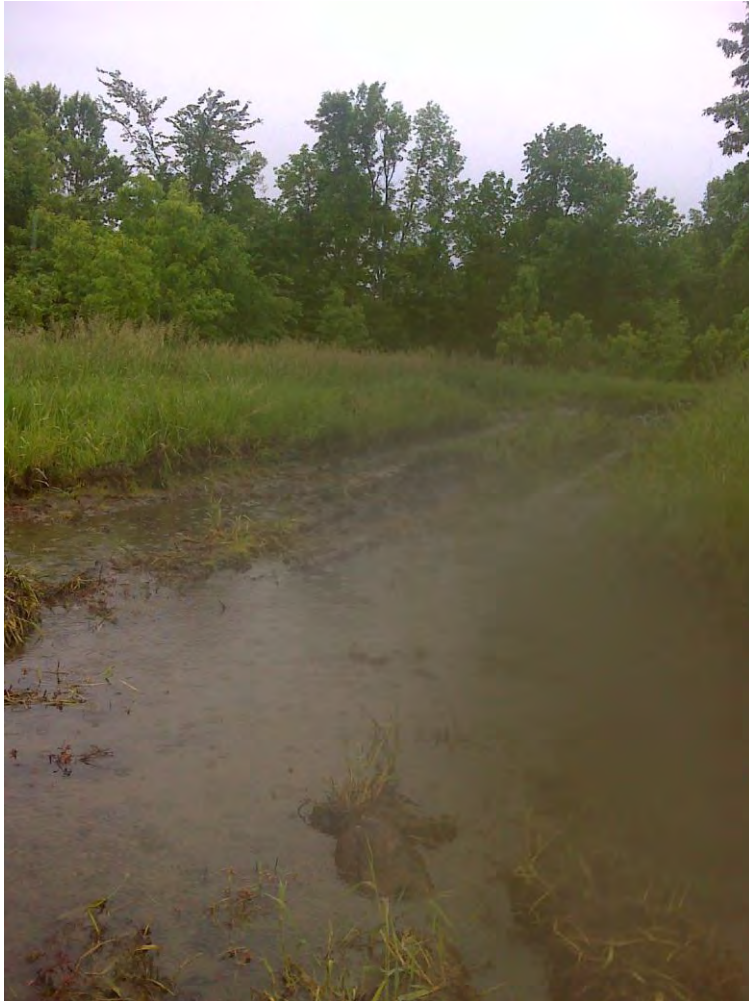
At crossing location WA02A the stream will be crossed by access road infrastructure and an overhead collector line. The stream substrate is 70% muck, 20% cobble and 10% bedrock. The stream width at high flow is approximately 10 m with a maximum pool depth of 20 cm. On June 1, 2012, at the crossing location, the water body was 1 m wide and 10 cm deep. The adjacent land use includes red cedar forest, deciduous forest and agricultural land use.

**Figure 4-1:**WA02A Crossing location

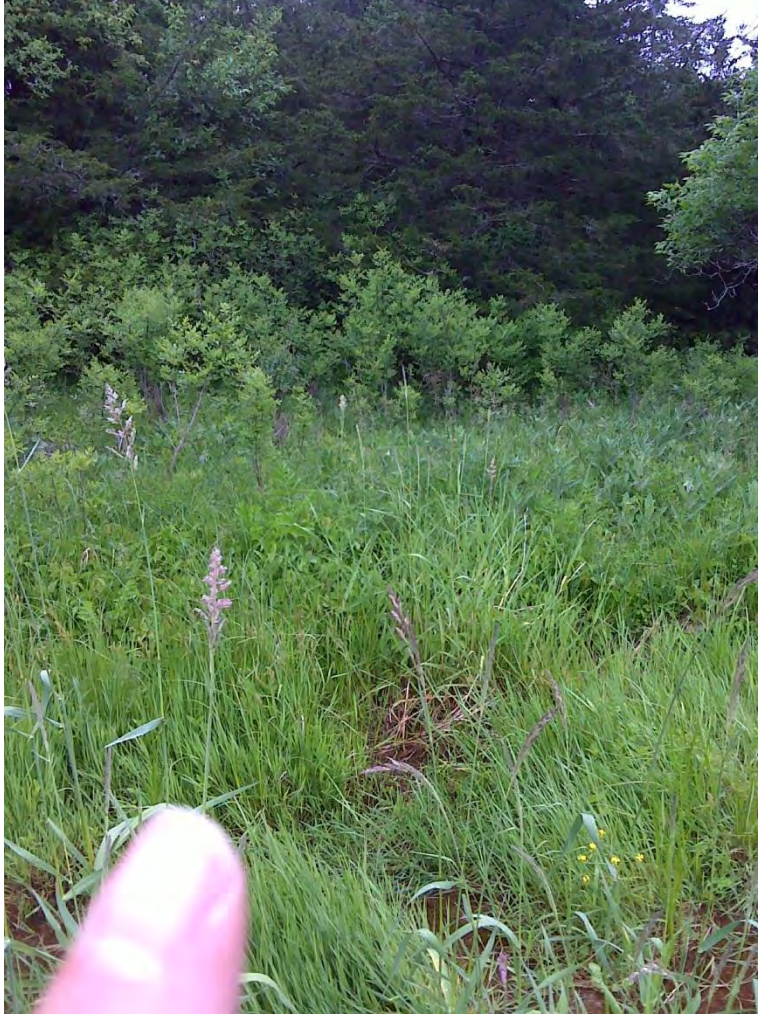
At crossing location WA02B the stream is intermittent and will be crossed by access road infrastructure and an overhead collector line. The stream substrate is 95% bedrock and 5% cobble. The stream width at high flow is approximately 5 m with a maximum pool depth of 30 cm. On June 1, 2012, at the crossing location, the water body was 1 m wide and 0 cm deep. Riparian vegetation includes elecampane, white ash, red cedar and prickly ash. The adjacent land use includes red cedar forest and CN railway tracks.

**Figure 4-2:** WA02B Crossing location

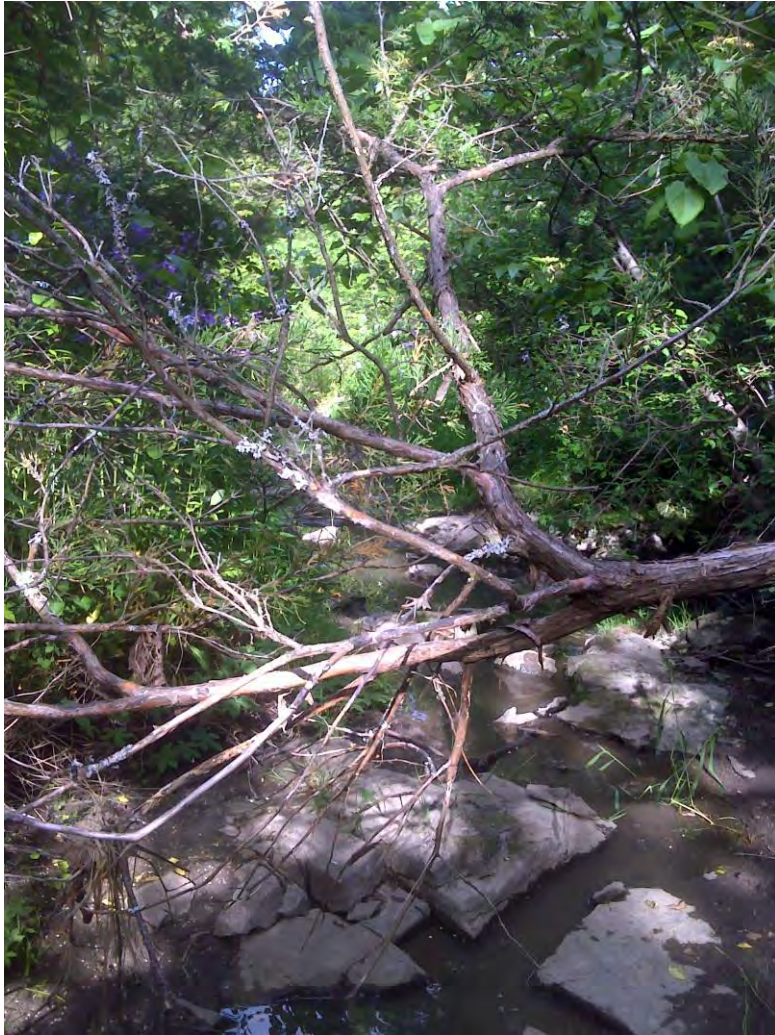
At crossing location WA02C the stream will be crossed by an overhead collector line only. The stream substrate is 40% gravel, 30% sand, 20% boulder and 10% silt. The stream width at high flow is approximately 3 m with a maximum pool depth of 30 cm. On May 31, 2012, at the crossing location, the water body was 1 m wide and 10 cm deep. Riparian vegetation includes nanny berry, downy arrowwood, fowl nannagrass, fragrant bedstraw and purple loosestrife. The adjacent land use includes red cedar forest and CN railway tracks.

**Figure 4-3:** WA02C Crossing location

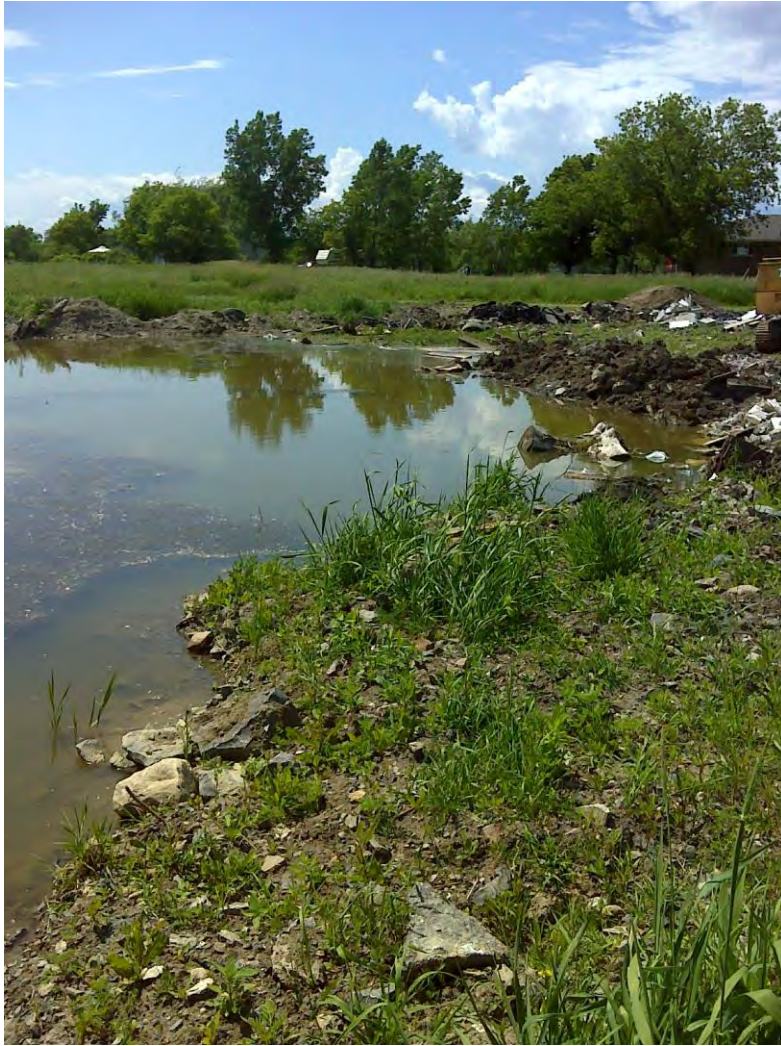
WA05 was identified during the Records Review and confirmed as an artificial, dugout pond more than 30 years old. This history was noted in a conversation with the landowner during SV2. Given that this potential water body is artificial, it is not considered a “water body” in O. Reg. 359/09 and therefore is not carried forward to the *Water Bodies Impact Assessment Report*.

**Figure 4-4:** WA05 Artificial, dugout pond

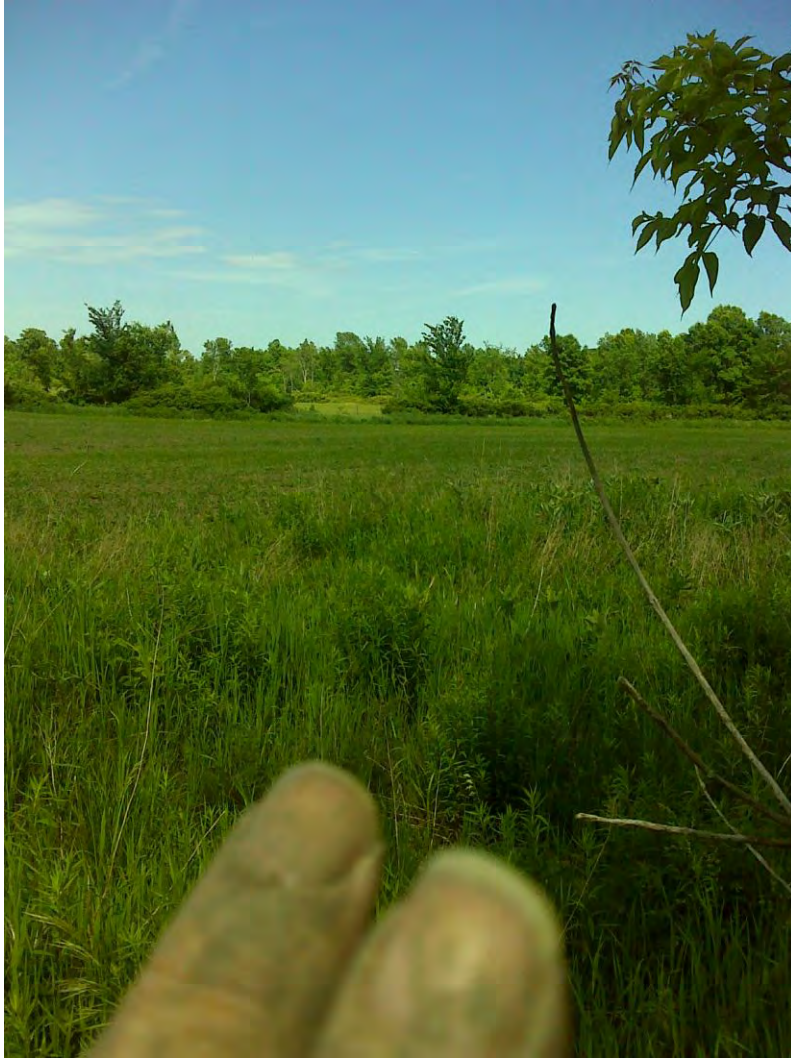
WA06 was identified during the Records Review and the boundaries of this feature were confirmed during SV3 (**Figure 4-5**). Aerial photography indicated a grassy swale crossing an agricultural field of row crops. During the site visit it was determined that there is no water body present; there was no indication of stream channelization and the entire area is grassed (dominated by graminoids). This feature is not considered a “water body” in O. Reg. 359/09 and therefore is not carried forward to the *Water Bodies Impact Assessment Report*.

**Figure 4-5:** WA06 Grassy swale

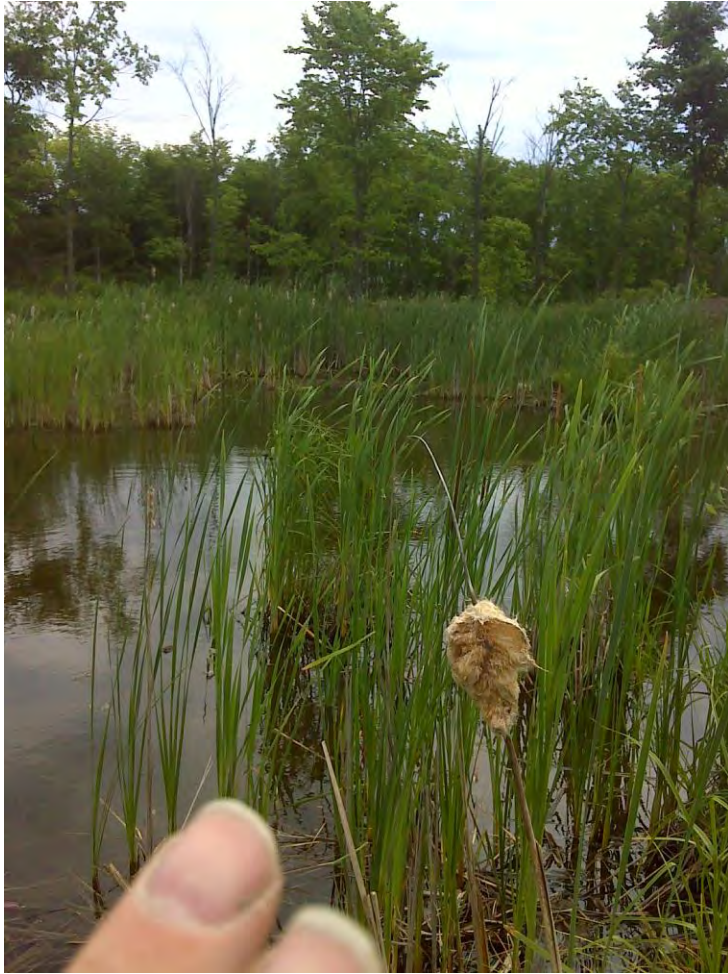
WA07 was identified during the Records Review and confirmed as a shallow marsh (ELC code: MAS2-1) during SV2. This feature is located 24 m from access road infrastructure and an overhead collector line. The substrate is 100% clay with riparian vegetation dominated by narrow leaved cattail, common cattail, reed canary grass, purple loosestrife, Canada rush, Bebb's sedge and awl-fruited sedge. Adjacent land use includes woodland, CN railway tracks and industry. The pH of this pond is 8.4 with a temperature of 20.4°C. This feature was not identified as suitable as fish habitat. Additional information on this water body can be seen in **Appendix D**. This feature is carried forward to the *Water Bodies Impact Assessment Report*.

**Figure 4-6:** WA07 Shallow marsh/pond

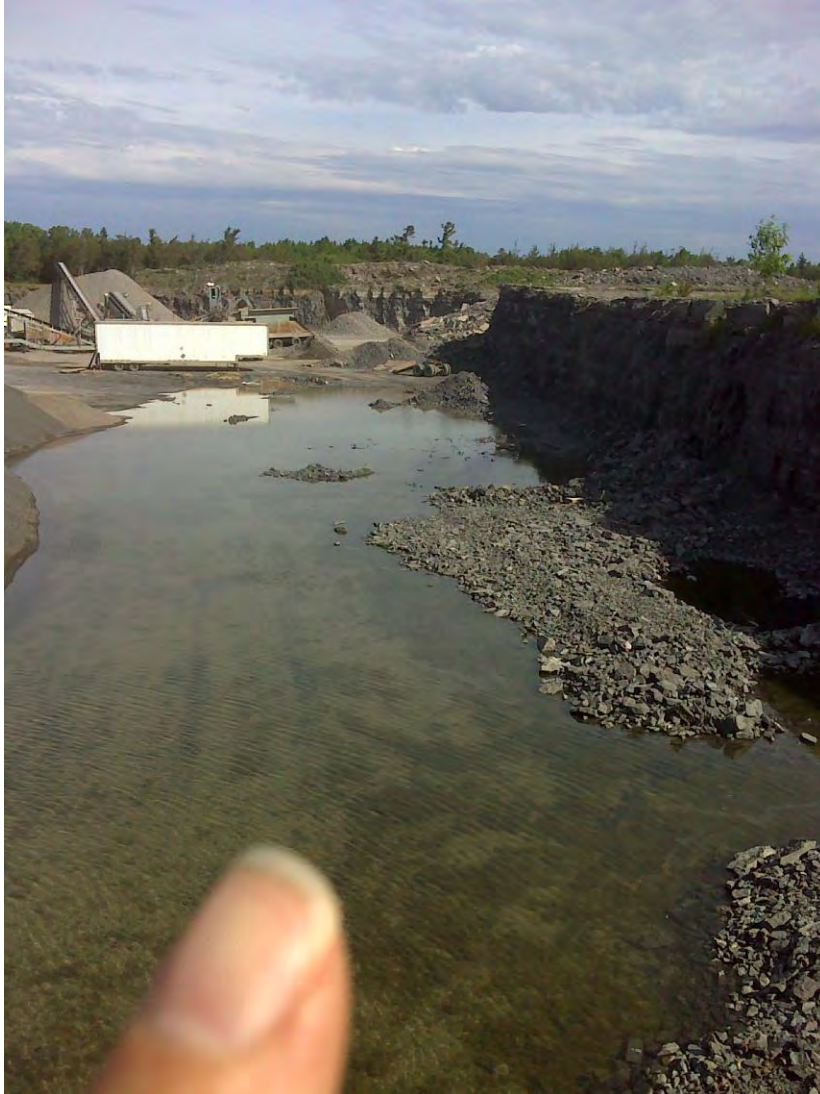
WA08 was identified during the Records Review and confirmed as an artificial pond within a quarry area during SV2. Given that this potential water body is both artificial and beyond the REA mandated buffer, it is not carried forward to the *Water Bodies Impact Assessment Report*.

**Figure 4-7:** WA08 Aggregate quarry

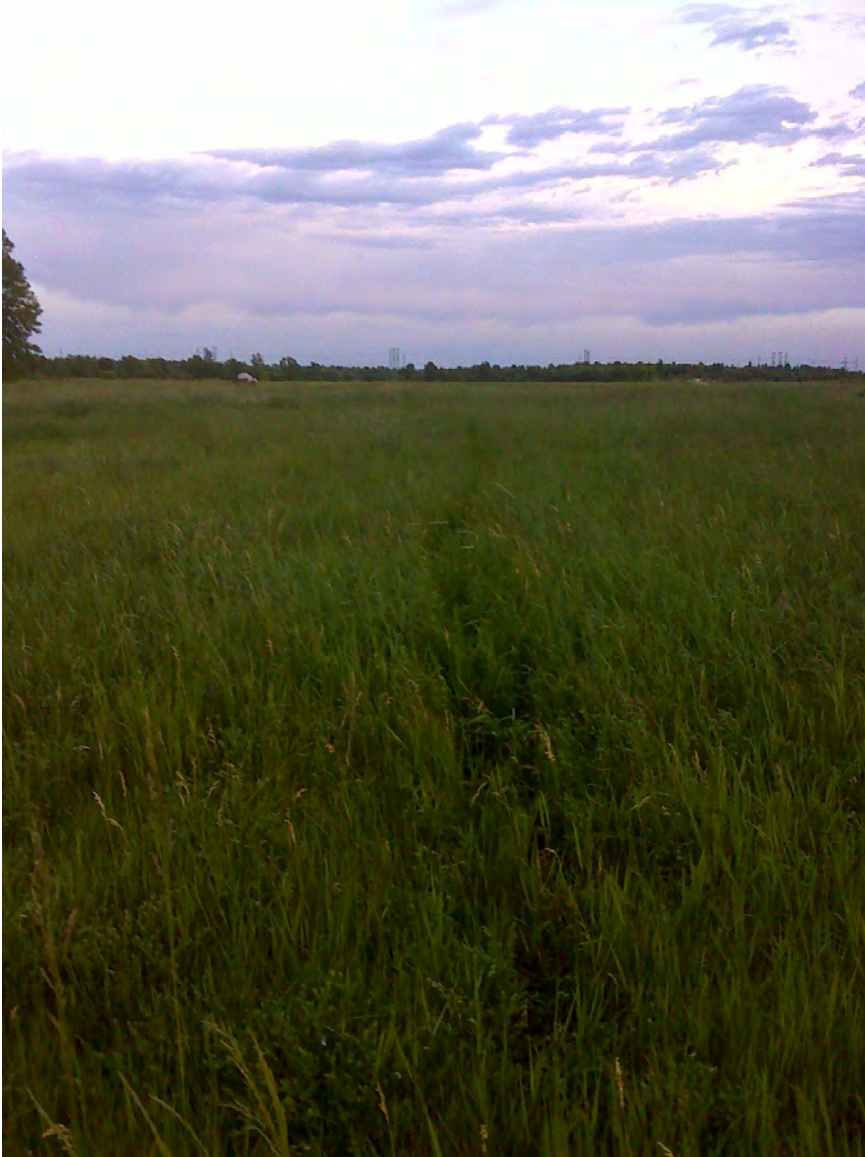
WA10 was identified during the Records Review as a grassy swale and the boundaries of this feature were confirmed during SV4 (**Figure 4-7**). During the site visit it was determined that there is no water body present; there was no indication of stream channelization and the entire area is grassed (dominated by graminoids). This feature is not considered a “water body” in O. Reg. 359/09 and therefore is not carried forward to the *Water Bodies Impact Assessment Report*.

**Figure 4-8:** WA10 Grassy swale

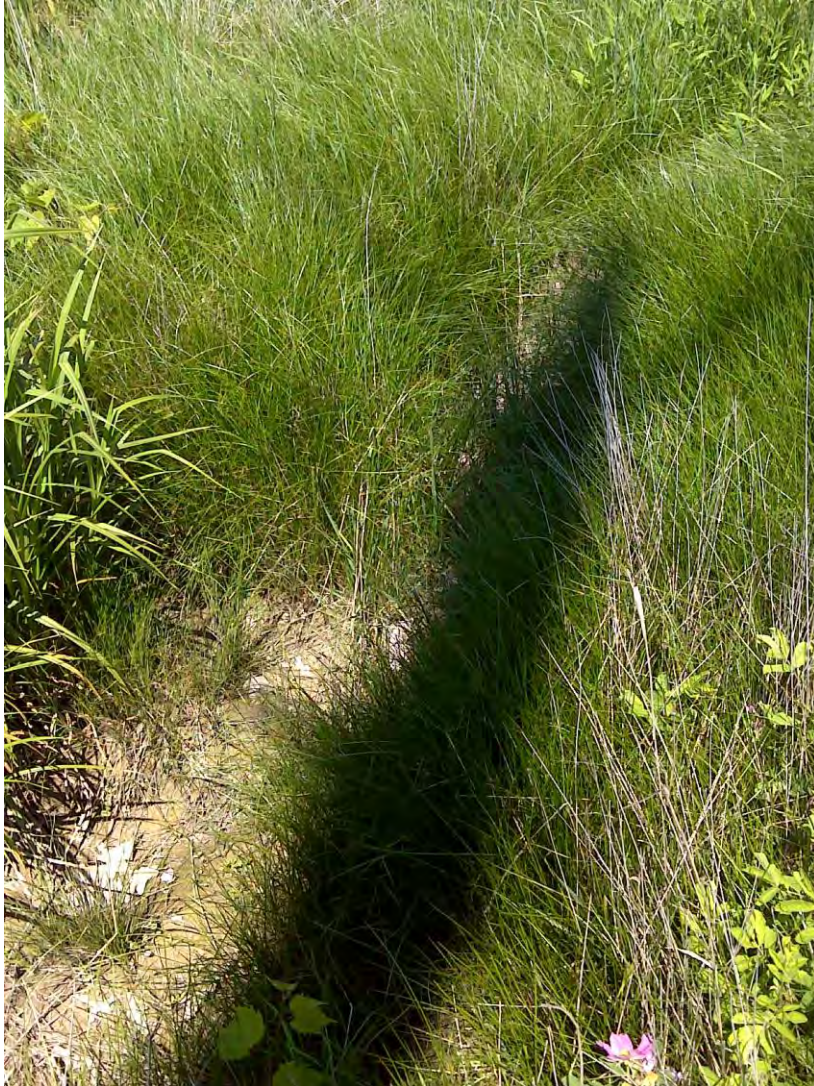
Drainage ditches were surveyed during the Site Investigation. The drainage ditches surveyed include: WA09 located on the north side of Millhaven Road (**Figure 4-9**); WA11 located on the north side of Taylor-Kidd Road (**Figure 4-10**); and WA12 located on the south side of Taylor-Kidd Road (**Figure 4-11**). The ditches act as temporary channels for surface drainage, and are not permanent or intermittent streams. There were no fish species identified or suitable fish habitat observed. No species of conservation concern were identified during surveys. These features are not considered “water bodies” in O. Reg. 359/09 and therefore are not carried forward to the *Water Bodies Impact Assessment Report*.

**Figure 4-9:** WA09 Roadside drainage ditch on north side of Millhaven Rd.

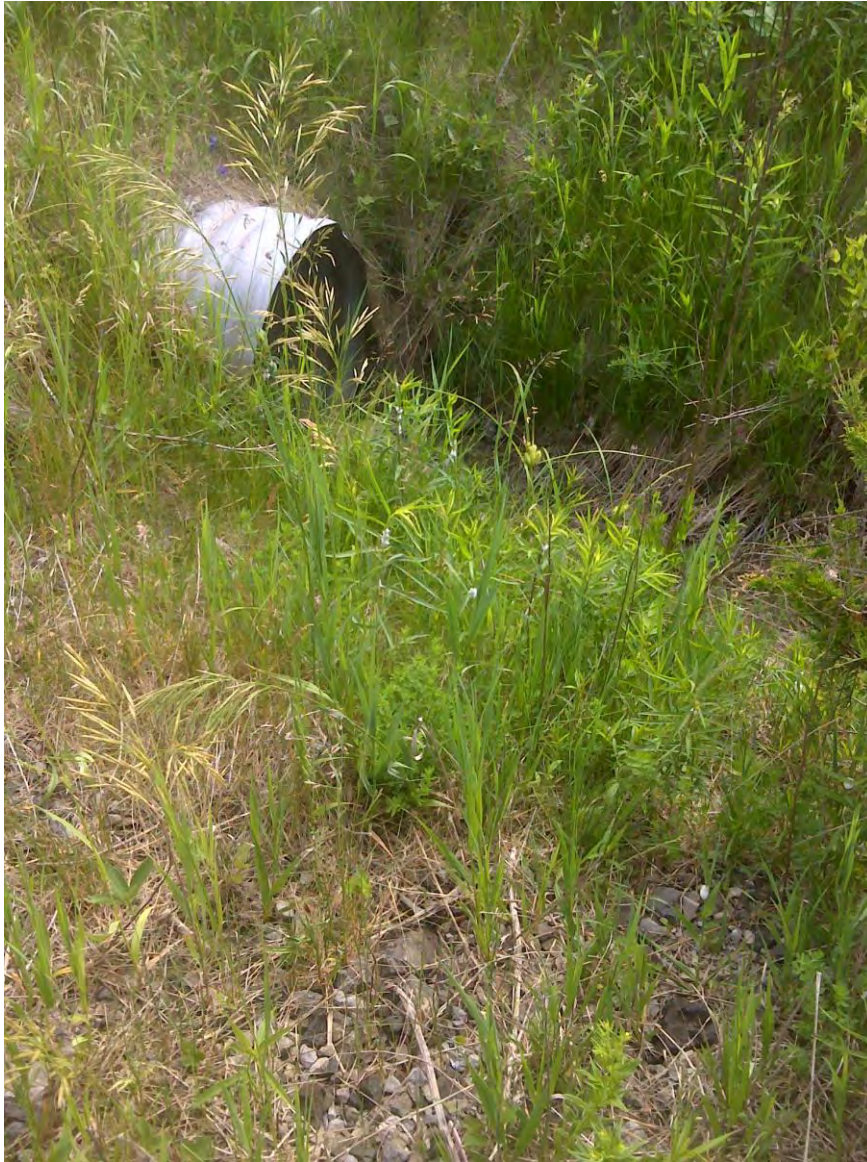
**Figure 4-10:** WA11 Drainage ditch along north side of Taylor-Kidd Road

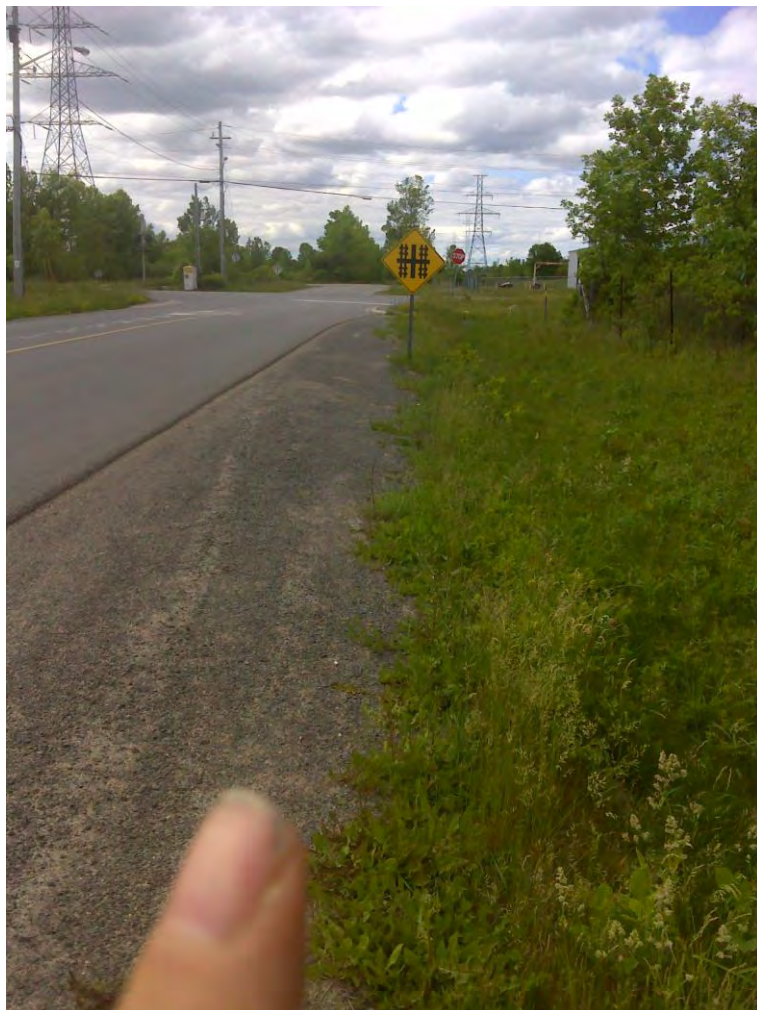
**Figure 4-11:** WA12 Drainage ditch along south side of Taylor-Kidd Road

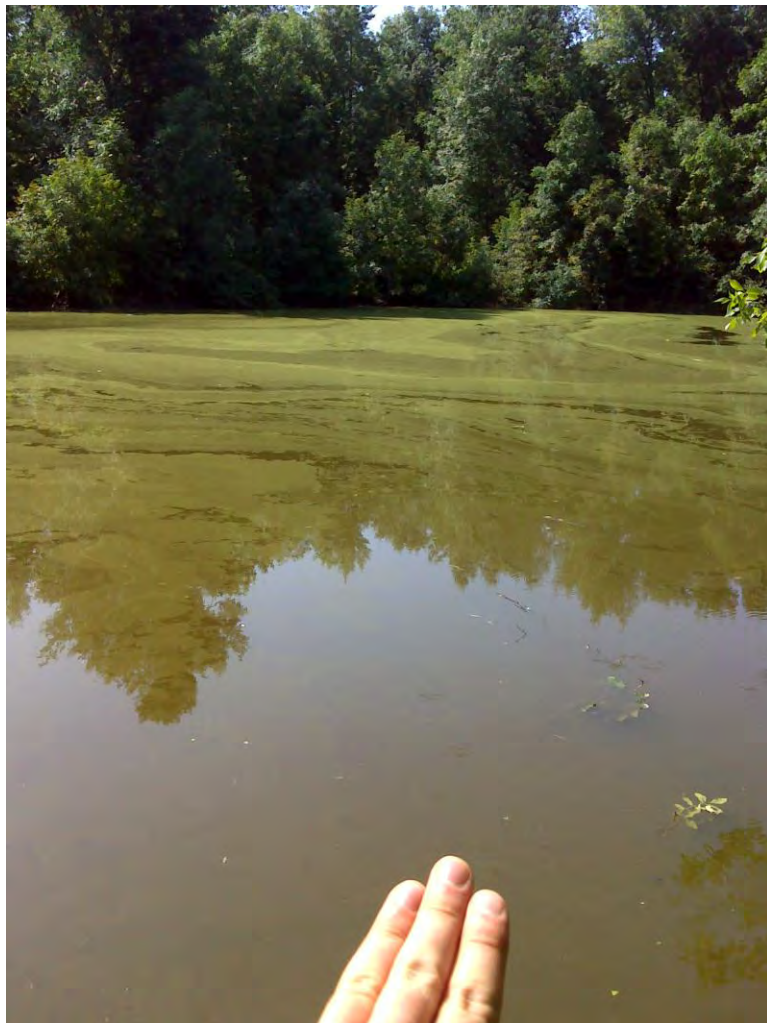
WA13 was identified and surveyed during SV7 and determined to be a natural pond (**Figure 4-12**). This feature is located 102 m from access road infrastructure and an overhead collector line. The substrate of this pond is 50% sand and 50% silt. Riparian vegetation includes green ash, prickly ash, milkweed, American elm and various upland species. Adjacent land use includes soy fields to the north and deciduous forest in all other directions. The pH of this pond is 8.0 with a temperature of 25°C. The pond is stagnant with heavy eutrophication noted. No amphibians were heard or seen, and the pond is not suitable fish habitat. Additional information on this water body can be seen in **Appendix D**. Given that this potential water bodies is natural, it are carried forward to the *Water Bodies Impact Assessment Report*.

**Figure 4-12:**WA13 Open Aquatic natural pond

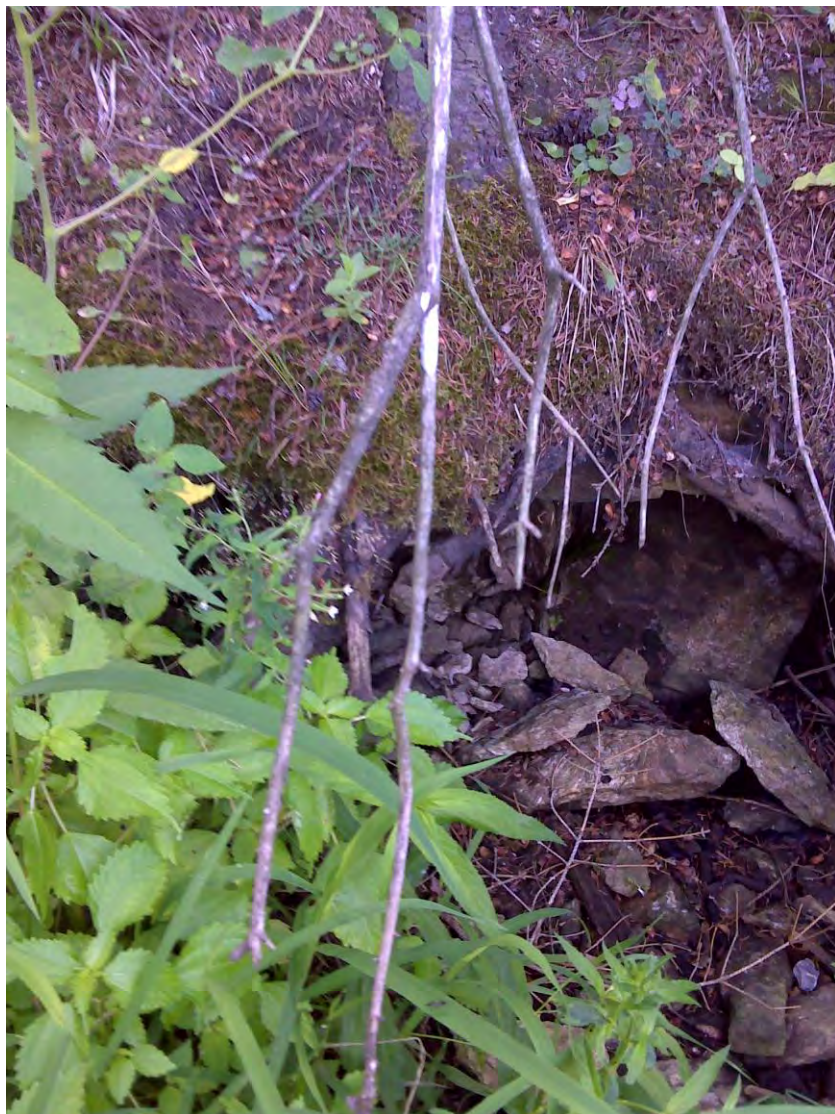
WA14 was a spring identified during SV4 and surveyed again during SI7. This feature is located 31 m from access road infrastructure and an overhead collector line. It is an intermittent spring emerging from beneath limestone layers under a tree. A channel of approximately 2 metres has been formed by flow of the spring before it empties into the permanent stream (WA02C). Some wetland vegetation is present in the channel and riparian vegetation includes arrowhead, bugleweed, puckweed, water plantain and jewelweed. The spring was dry when surveyed August 16, 2012. Additional information on this water body can be seen in **Appendix D**. Given that this potential water bodies is spring, it is carried forward to the *Water Bodies Impact Assessment Report*.

**Figure 4-13:** WA14 Spring

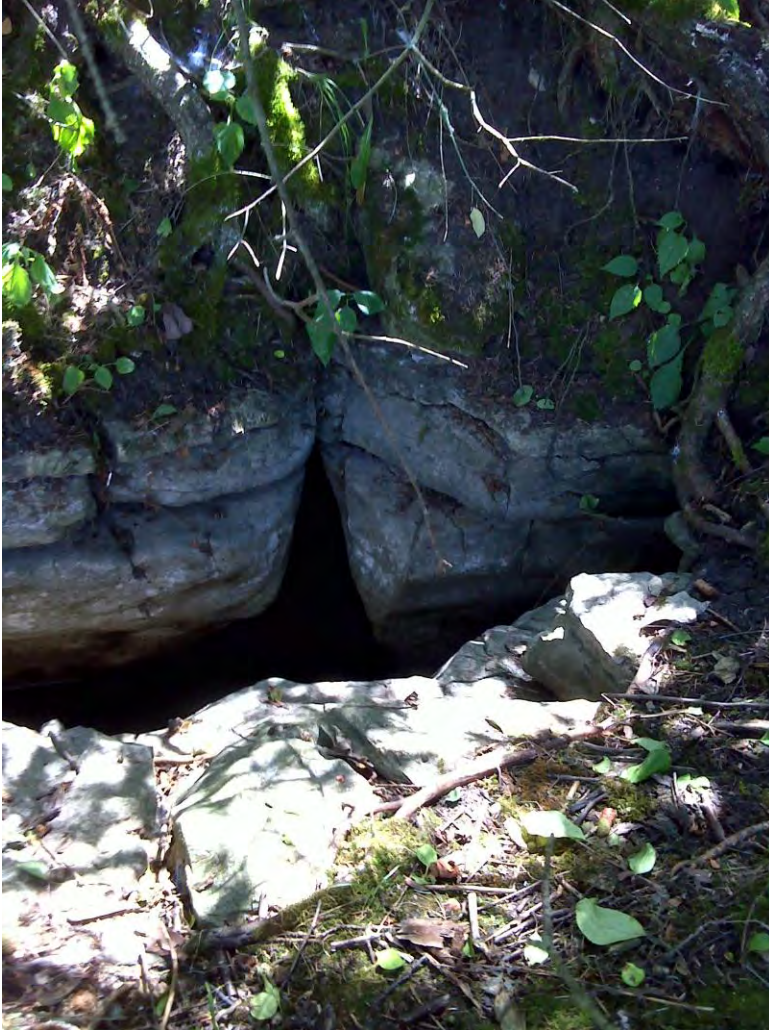
WA15 was a spring identified and surveyed during SI7 (**Figure 4-14**). This feature is located 51 m from access road infrastructure and an overhead collector line. It is an intermittent spring emerging from beneath limestone layers. A channel of approximately 3 metres width has been formed by the spring before it empties into a wetland (WE05-6). There are large boulders and some wetland vegetation present in the channel. The spring was dry surveyed on August 16, 2012. Additional information on this water body can be seen in **Appendix D**. This water body is carried forward to the *Water Bodies Impact Assessment Report*.

**Figure 4-14:** WA15 Spring

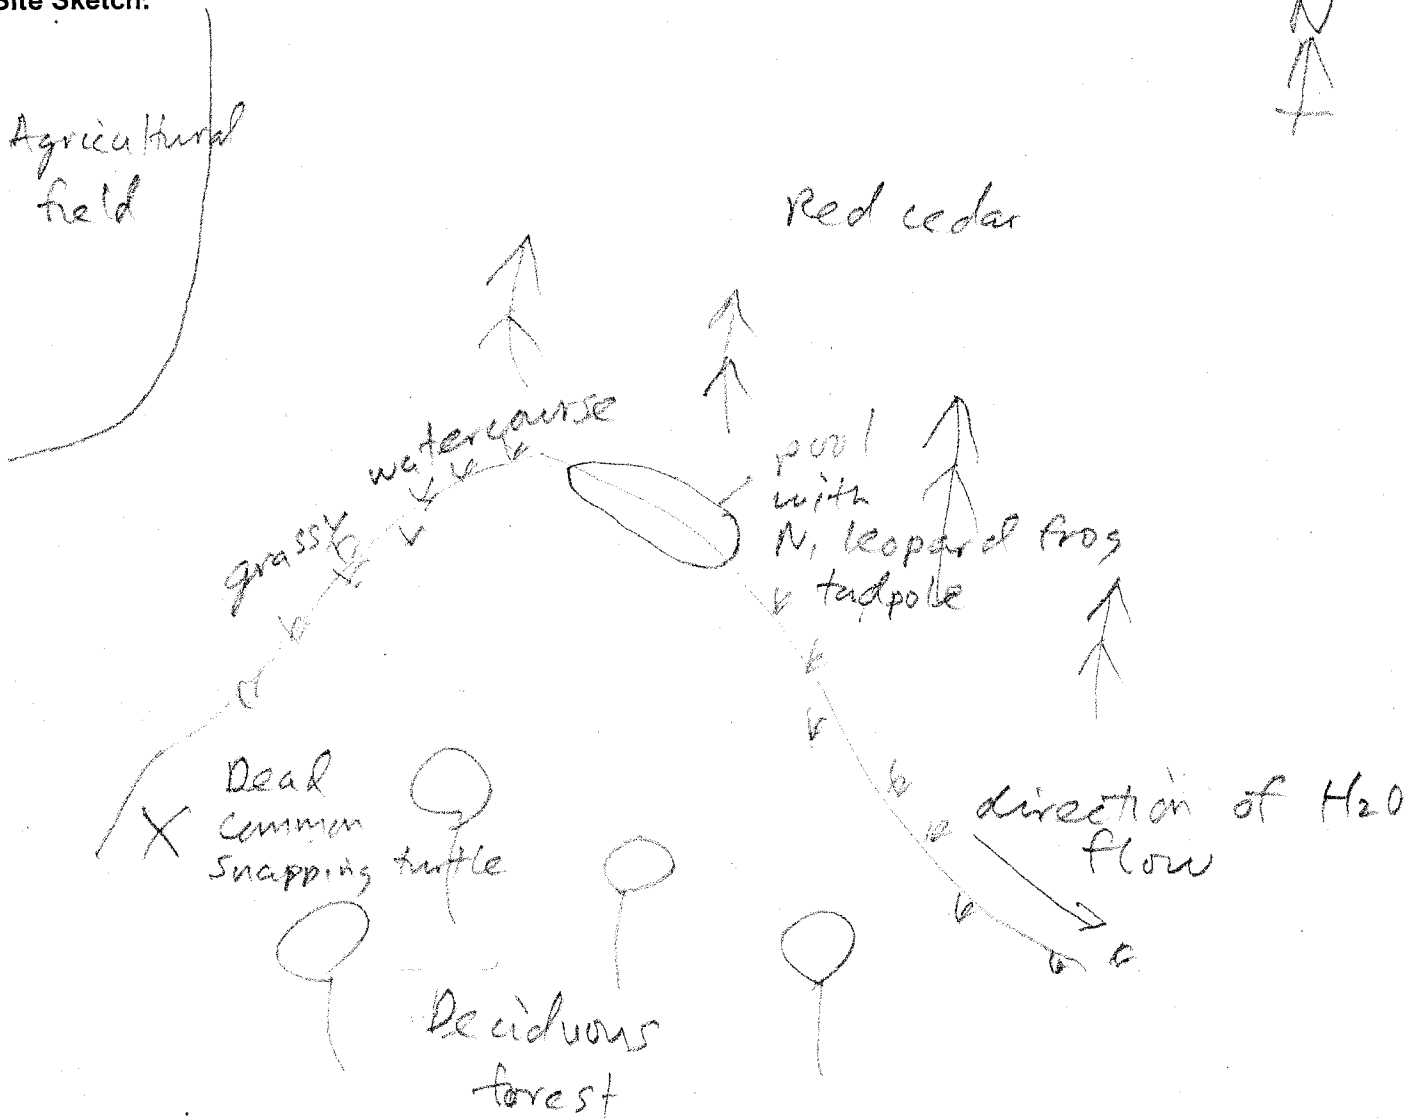
Site Sketch:

Northern leopard frog tadpoles present in standing pool at crossing. Dead common snapping turtle found south of pool.  
Pollution sources: Agricultural field to Northwest  
Not suitable fish habitat, none observed
